POWERS & SONS BENCHMARKING REVIEW

2000 Toyota Tundra

VW Passat/Audi A4 Tie Rod End

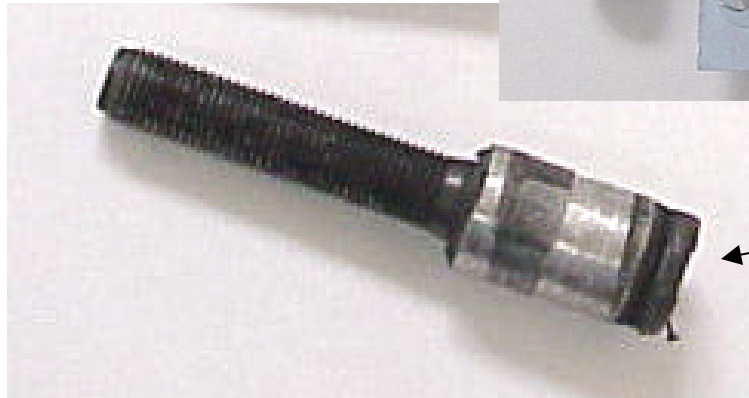
Aluminum
Housing

Rubber
Isolator

- The following example shows multiple uses of benchmarking
- VW Passat tie rod end was originally added to library because of aluminum housing and rubber isolator

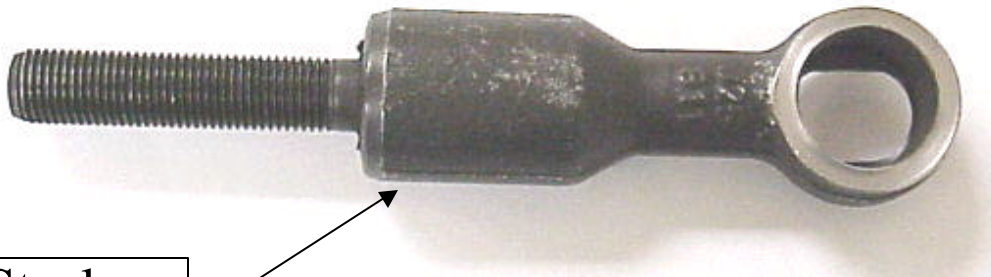
Service Passat Outer End

Steel
Housing

- Why Change housing from Aluminum to Steel?
 - Lower material cost?
 - Higher pull out strength if seal fails and joint wears out?
